Contract #: 04-0120F4Cty: SF/ALA Rte: 80 PM: 13.2/13.9File #: 99.28**WELDING INSPECTION REPORT****Resident Engineer:**Siegenthaler, Peter**Address:** 333 Burma Road**City:** Oakland, CA 94607**Report No:** WIR-026409**Date Inspected:** 05-Sep-2011**Project Name:** SAS Superstructure**OSM Arrival Time:** 1200**Prime Contractor:** American Bridge/Fluor Enterprises, a JV**OSM Departure Time:** 2200**Contractor:** Zhenhua Port Machinery Company, Ltd (ZPMC) Chanxing Island**Location:** Shanghai, China

Bridge No: 34-0006**Component:** Bike Path, Traveler Rail**Summary of Items Observed:**

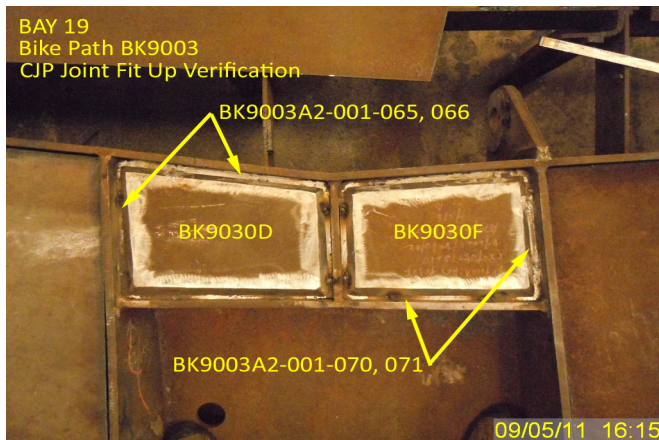
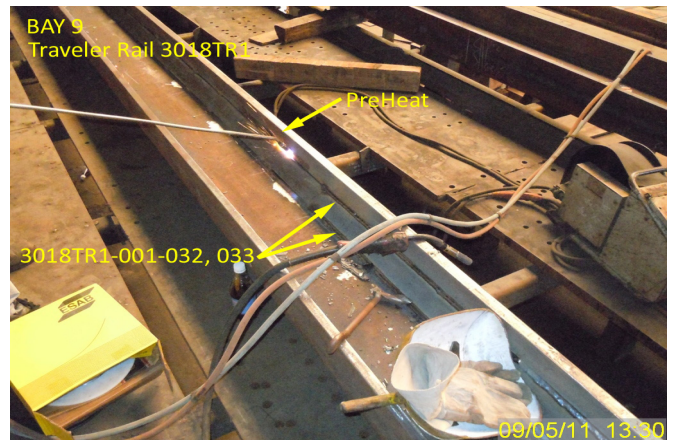
This QA Inspector observed the fit up of CJP weld joints located on Bike Path segment BK9003. Verified the fit up of the following CJP weld joints BK9003A2-001-065~068, and BK9003A2-001-069~072, these joints appear to conform to the requirements of the approved contract documents. Tack welding of these joints was performed by certified welder 062749. QC Guo Xing Hui present during welding.

Welding variables recorded by QC appeared to comply with the approved Welding Procedure Specification (WPS).

Component: Traveler Rail

PCMK: 3018TR1

Weld Number: 032, 033
